2017 Hurricane Harvey Deployment  
Arkema Facility Response  
8/31/2017 1:45:27 PM

***2017 ASPECT Preliminary Report  
Arkema Plant Response  
Crosby, TX***

***August 31, 2017  
0600 hrs to 1300 hrs***

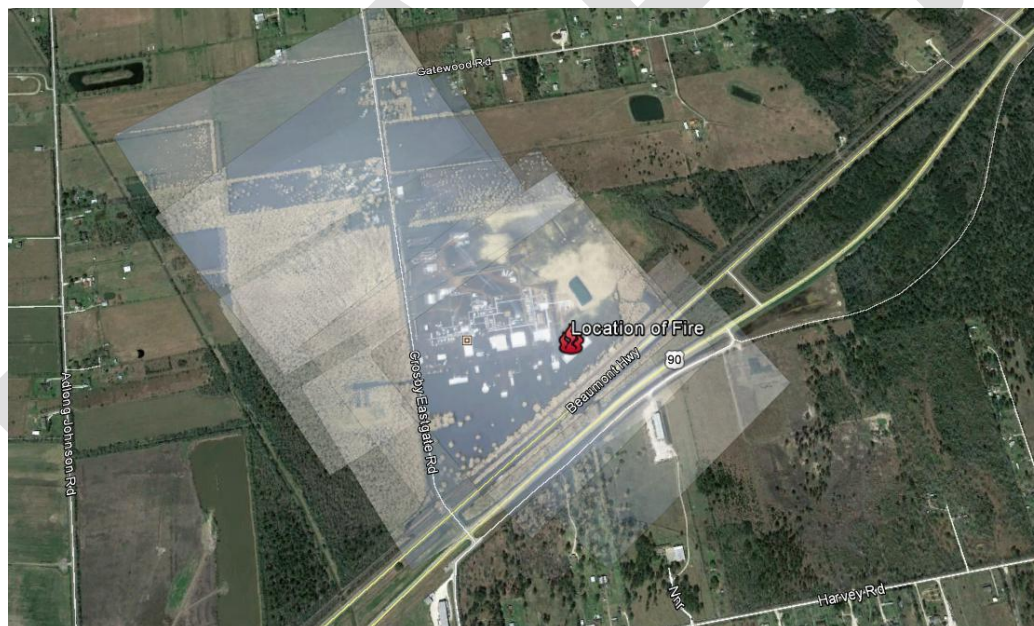
Figures 2 & 3 show a visible image of the facility with no observed plume and the flight path highlighted when IR sensors were active.

*Figure 2: Low resolution aerial images pulled from the aircraft while in flight over the facility, 30 August 2017 at about 0730 hrs CST.*

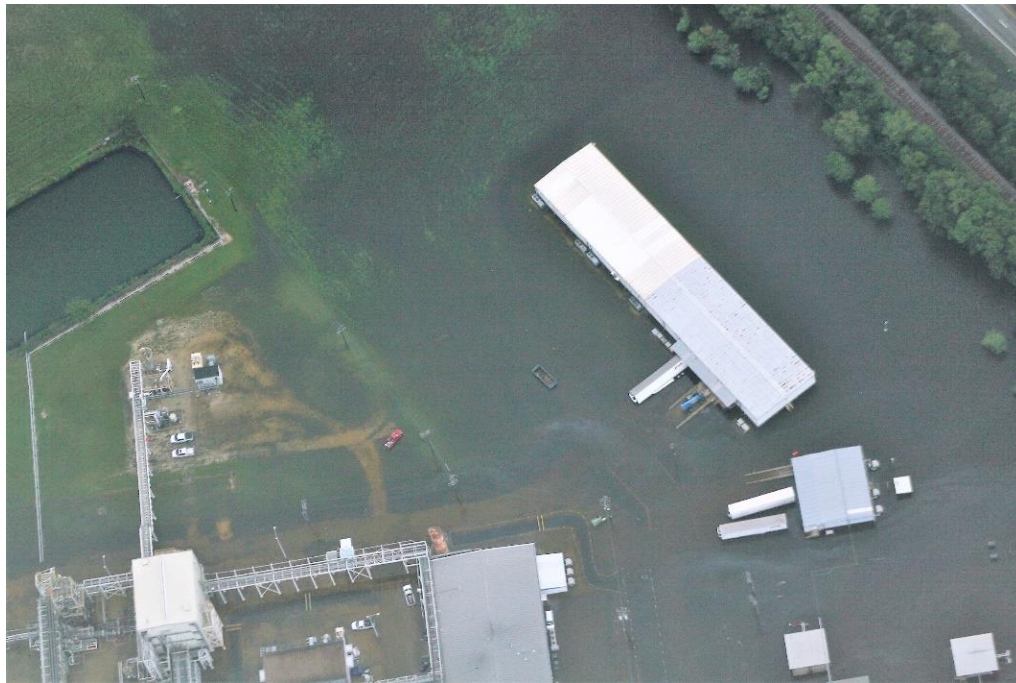
*Figure 3: Oblique photo prior to explosion/fire on 30 August 2017.*

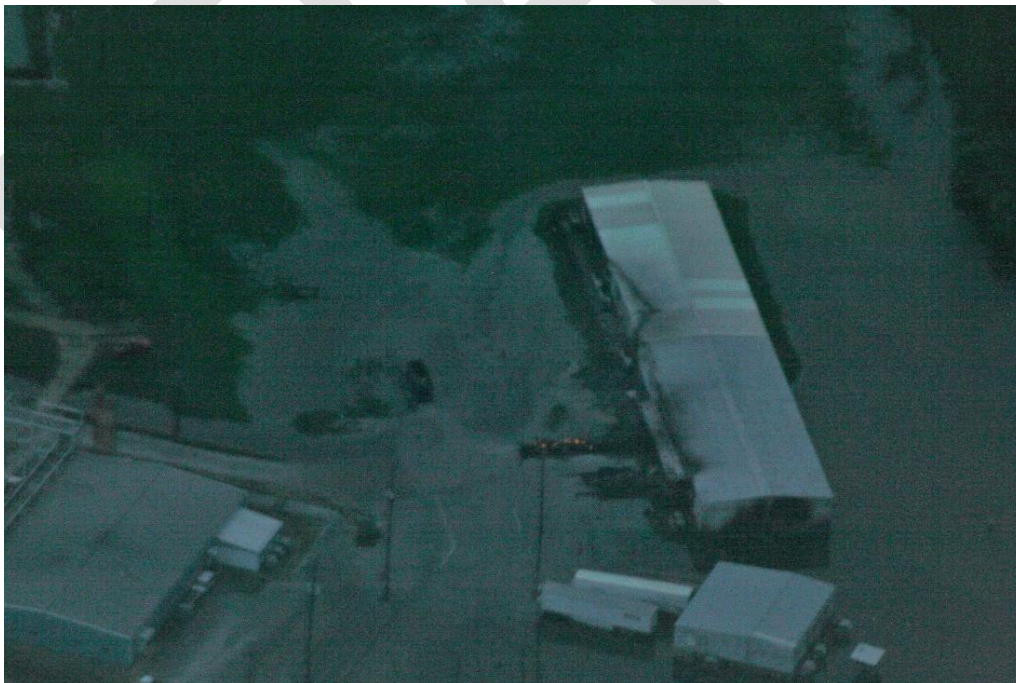
*Figure 4: Oblique photo after explosion/fire on 31 August 2017*

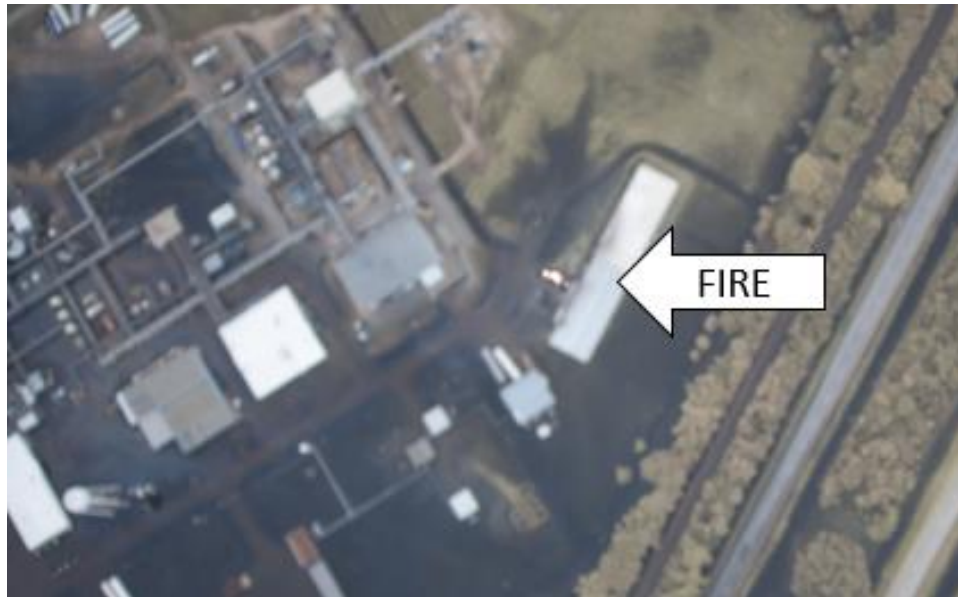
High-resolution aerial photos provide downward view of the area. Figures 5 has been enhanced due to poor visual conditions when the aircraft arrived on site. Foggy weather combined with low light conditions is reflected in this image.

*Figure 5: Aerial photo over the site captured during the morning flight on 31 August 2017.*

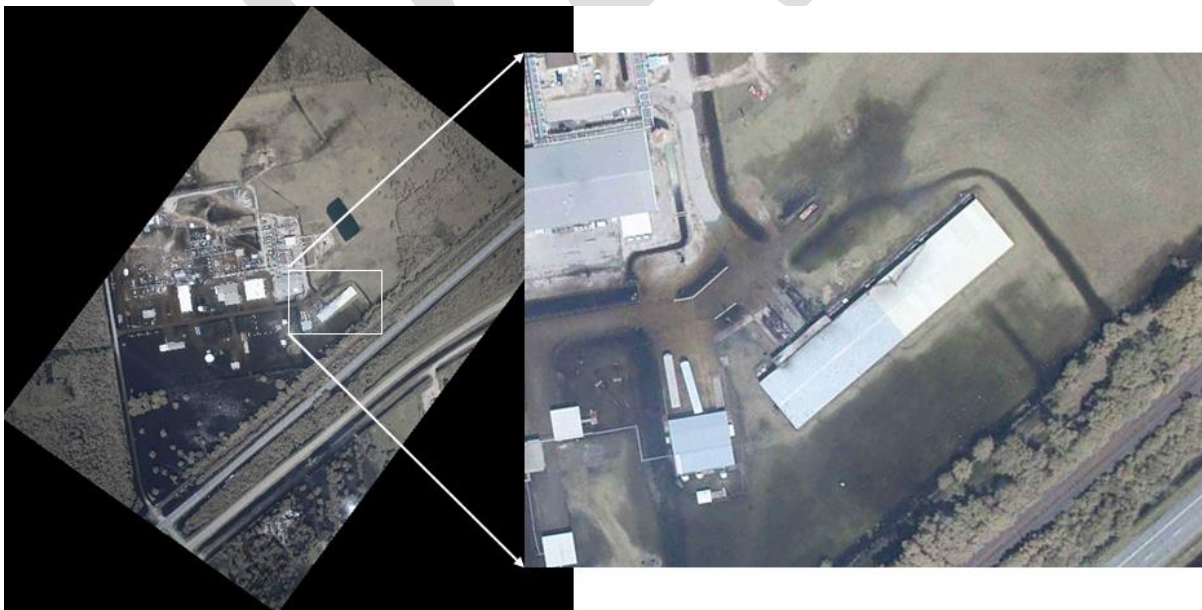
*Figure 6: Low resolution aerial image retrieved from the aircraft during the afternoon sortie, approximately 1335 hrs. A copy of the entire image will be provided in an email. A portion of the photo was enlarged to show the affected building.*

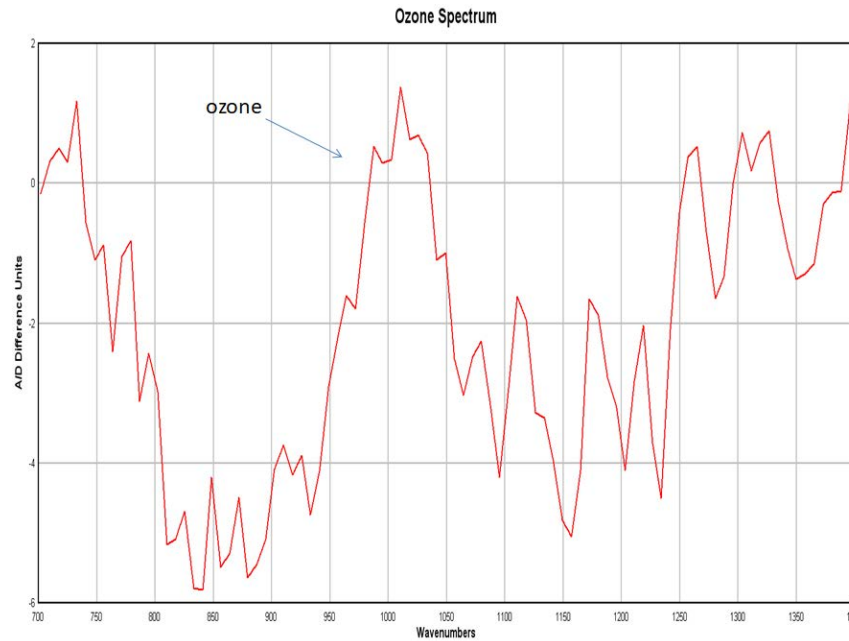
Figure 8: Passive (remotely detected at 2,800 ft AGL) FTIR spectra showing ozone, a commonly occurring air pollutant. This confirms that the instrument was operating properly.
